# Manhole Inspection Summary

Manhole # S130\_\_020MH

**Location** Address: **2823 Font Hill Ave** Cross Street: **Frederick Ave**

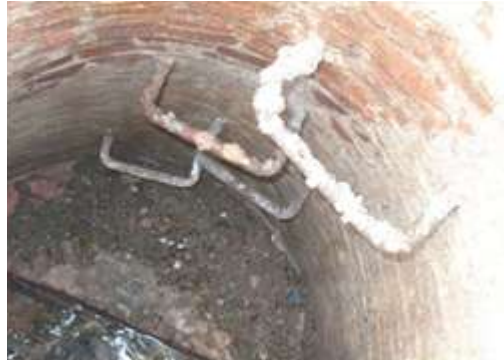
Defect 6

**Steps** Count: **4** Missing: **0** ☒ **Corroded**

steps corroded

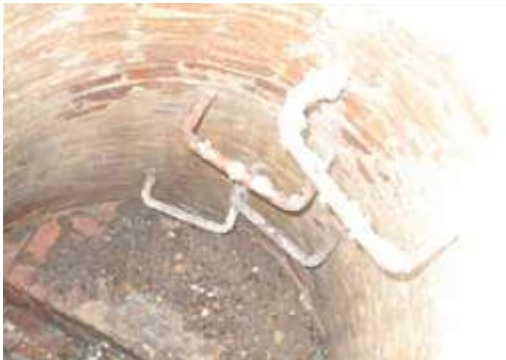
Defect 5

**Surcharge** ☒ **Evidence Of Surcharge** Depth: **4** (ft.) ☐ Active Surcharge Present

surcharge evidence 4 feet

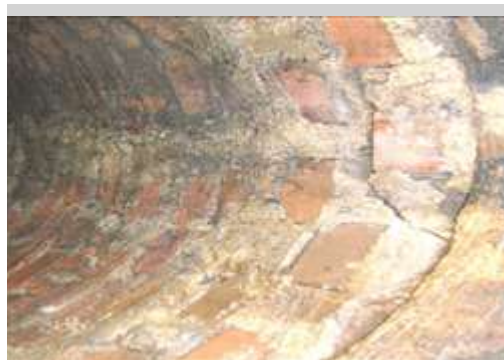
Defect 4

Condition: ☐ Sound ☐ Cracked ☐ Root Intrusion ☐ Loose Brick ☒ **Deteriorated**

Infiltration: ☐ None ☒ **Joint** ☐ Cracks ☐ Mortar ☐ Roots ☐ Wall

chimney deterioration and infiltration

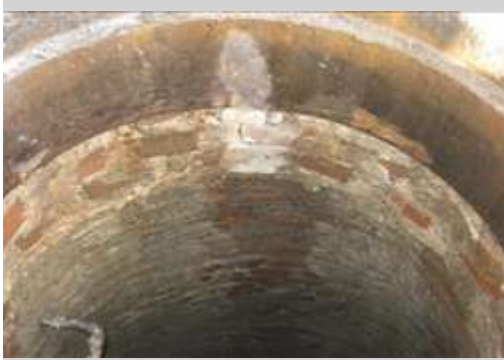
Defect 3

**Frame** Offset: **0** (in.) Condition: ☐ Sound ☐ Cracked ☒ **Leaks**

Infiltration: ☐ None ☐ Joint ☐ Cracks ☐ Mortar ☐ Roots ☒ **Wall**

corbel and frame infiltration

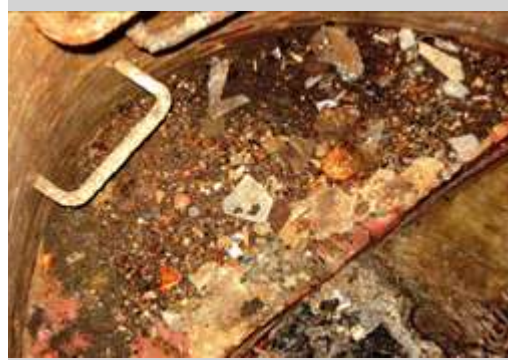
Defect 2

Condition: ☐ Sound ☐ Cracked ☐ Root Intrusion ☐ Deteriorated ☐ Leaks ☒ **Debris**

bench heavy debris sediment

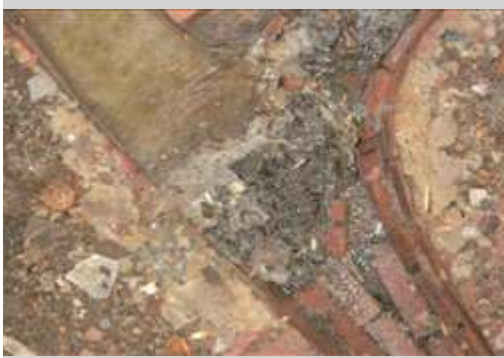
Defect 1

Condition: ☐ Sound ☐ Cracked ☐ Root Intrusion ☐ Deteriorated ☐ Leaks ☒ **Debris**

channel heavy debris
